Flywheel

Clutch Cover/Intermediate Plate Failures

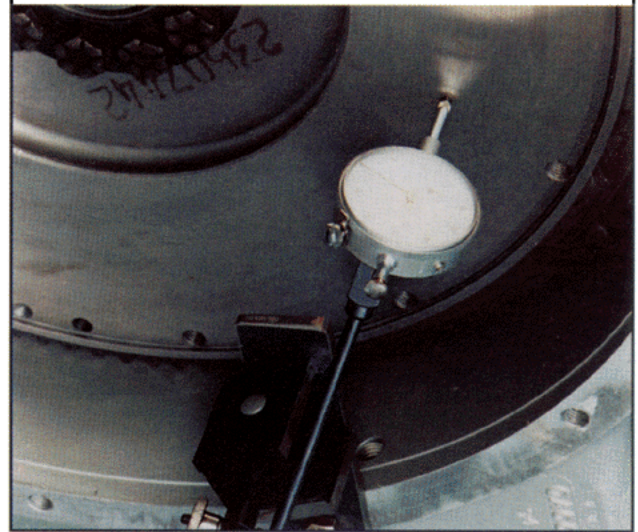
Figure 14

Too Much Runout or Taper on Friction Surface

Driver Notices: Clutch engagement is erratic. Clutch drags when disengaged.

Observations: The runout is more than engine manufacturer's specifications. An abnormal wear pattern is in the area where the disc touches the flywheel.

Causes: The flywheel is damaged or not machined correctly.

Correction: Machine or replace the flywheel according to procedure and specifications of vehicle or engine manufacturer. This condition is not covered under Meritor warranty.

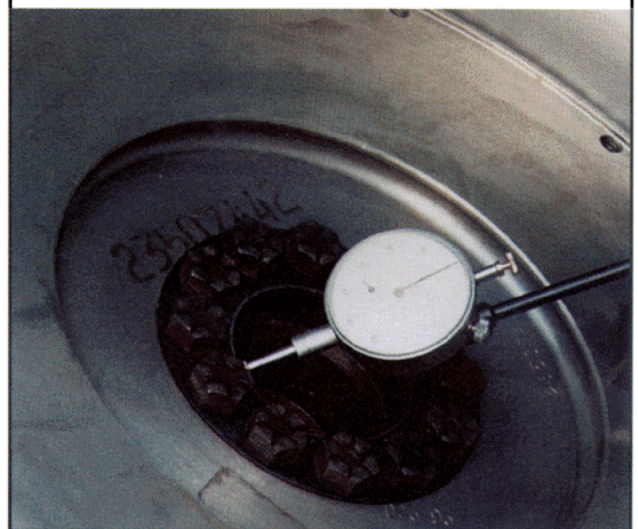
Figure 15

Too Much Runout in Pilot Bearing Bore

Driver Notices: Clutch disengagement is erratic and a squeal noise is heard. The clutch drags.

Observations: The pilot bearing outer surface is damaged. Heat damage is visible.

Causes: Runout of the pilot bearing bore is out-of-specification.

Correction: Check the runout of the pilot bearing bore. Service the flywheel according to the procedure of the vehicle or engine manufacturer. Replace the pilot bearing. This condition is not covered under Meritor warranty.

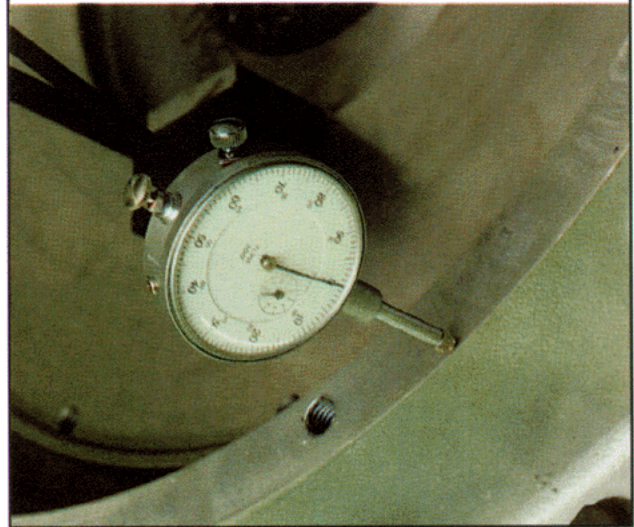
Figure 16

Too Much Runout on Outer Surface

Driver Notices: Clutch is difficult to engage and disengage.

Observations: The runout is more than engine manufacturer's specifications.

Causes: The engine and the transmission are not correctly aligned.

Correction: Replace the flywheel housing. Check the engine-to-transmission alignment. This condition is not covered under Meritor warranty.

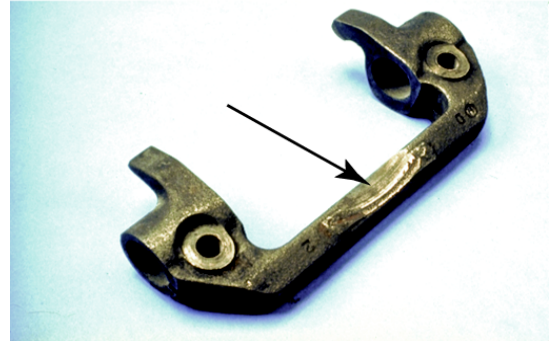
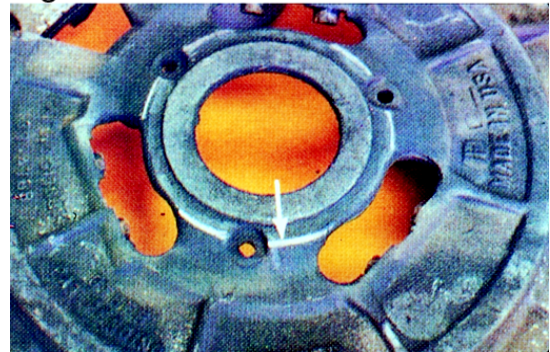
Failure - Yoke Bridge Rubbing into Cover

The arrows in Figures 1 and 2 show the areas of contact between the release yoke bridge and the clutch cover. Overstroking of the yoke, in an attempt to obtain the required 1/2" - 1" clutch brake squeeze, is a typical cause of this failure.

The reason that normal clutch brake squeeze cannot be obtained may be due to one or more of the following situations:

- Worn clutch brake
- Broken or missing clutch brake
- Worn or incorrect transmission bearing retainer cap (refer to Figure 3)
- Excessive wear on release bearing wearing pads and/or the fingers of the yoke (refer to Figure 1)
- Improper set up of the linkage system. Consult your OEM service manual
- Incorrect yoke installed

Note: The clutch cover can be reused if the above items are corrected, a new yoke is installed, and there are no broken or cracked parts on the cover. The above failure is typically preceded by a noise complaint and/or vibrating clutch pedal at the point where the clutch pedal is fully depressed. Depending upon the amount of wear (at the bearing cap and/or yoke fingers/wear pads), it may be possible to adjust the linkage to eliminate the noise complaint.

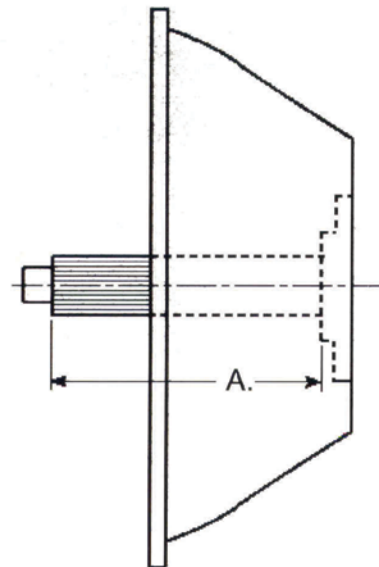
Figure 3

Dimension A, based on SAE standards, is 8.657" (219.9 mm) nominal, and should not be greater than 8.71" (221.5 mm) Ref. 1990 S.A.E. handbook 4:36.106

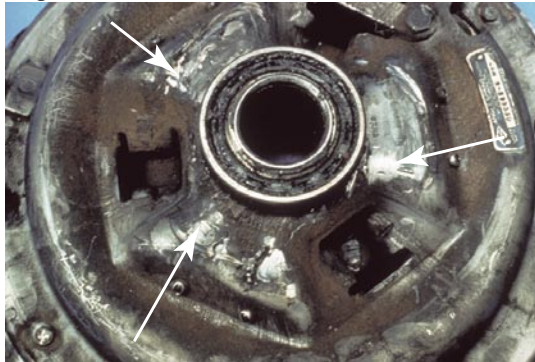
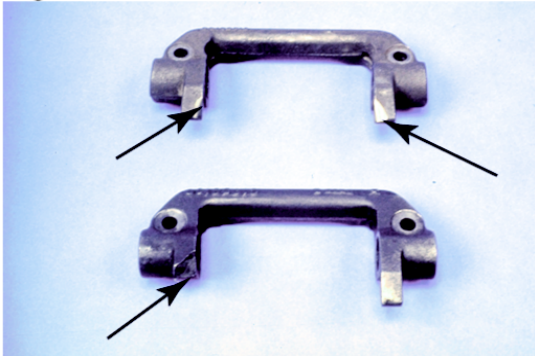
Failure - Yoke Fingers Rubbing into Clutch Cover

Figures 4 - 5 show the damage that results when the release yoke contacts the clutch cover. More specifically, the fingers have become pinched between the clutch cover and release bearing, resulting in one or more of the following:

- A broken /cracked release bearing housing (not shown)
- Damage to the clutch cover (see arrows, Figure 4)
- Wear to the backside of the yoke fingers (see arrows in Figure 5, top yoke)
- Broken yoke finger(s) (see arrow in Figure 5 bottom yoke)

- Linkage system broke, allowing the loose yoke to contact cover
- Linkage system was improperly reinstalled (example: forgetting to reinstall the cotter key, allowing the clevis pin to come out)
- Adjusting the clutch with the linkage instead of internally using the adjusting ring
- Rotating the ring the wrong direction (counterclockwise instead of clockwise) when adjusting for clutch wear

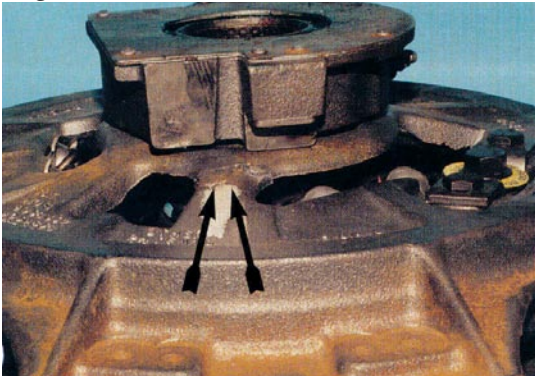
Fig 6

Failure - Cracked/Broken Clutch Cover

Referring to the arrow in Figure 6, this brand new clutch (Easy-Pedal 1402 S.D.) was damaged during transmission installation. More specifically, the release yoke "fingers" were elevated to the "straight out position" and were allowed to jam into the clutch cover. Subsequent damage might be a broken finger(s)(Figure 5) or bent release yoke / cross shafts. As a result, it is important that these parts be inspected for damage (and replaced if damaged) before installing a new clutch.

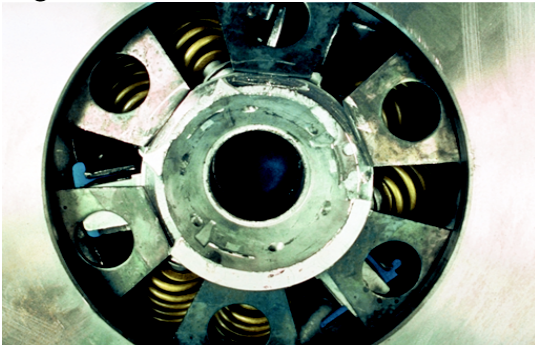
Fig 7

Failure - Broken Retainer Assembly

Figure 7 shows what can happen when the levers break through the retainer's nose. The primary cause of this failure is allowing the transmission to hang unsupported in the driven disc during transmission installation.

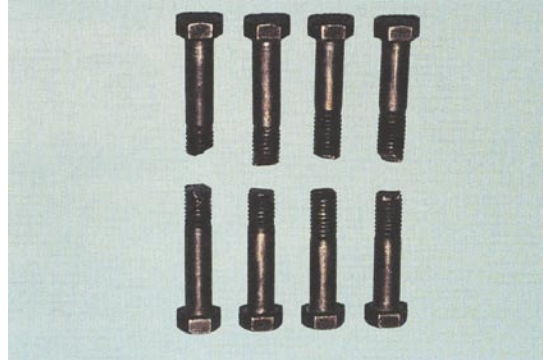
Fig 8

Failure - Clutch Cover Detached from Flywheel

The broken mounting bolts, show in Figure 8, are the direct result of insufficient torquing of these (8) bolts to the flywheel. More specifically, these bolts were loose enough to allow the clutch cover to hammer back and forth against each bolt until they broke. Also, the (8) mounting bolt holes in the clutch cover were "egg-shaped" as a result of the constant hammering.

Another potential cause of the above failure would be the over-torquing of the mounting bolts. Doing so can cause the bolts to fracture and eventually separate from the flywheel. Combining this scenario with low grade mounting bolts will increase the chances of failure.

Correct mounting bolt torque:
45 ft. lbs. on 15½"
35 ft. lbs. on 14"

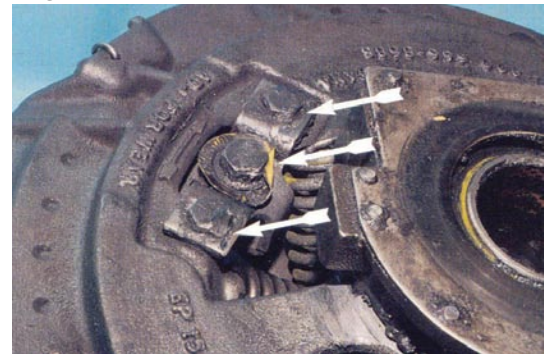
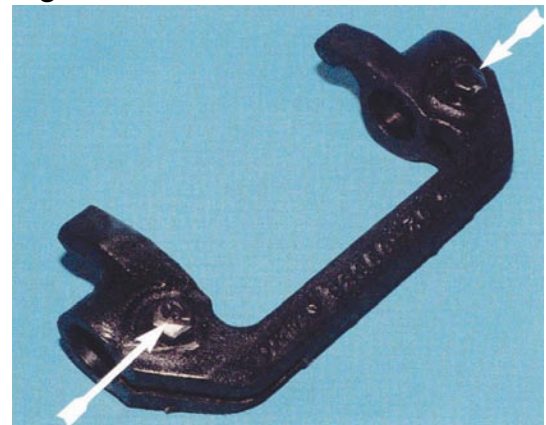
Additional damage occurred to both the clutch cover and the release yoke as a result of their interference with each other (refer to the arrows in Figures 9 and 10). It is worth noting that this service clutch had accumulated 50,000+ miles before it failed.

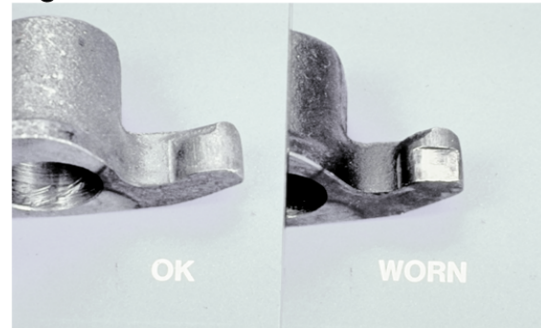
Fig 86

Failure - Worn Fingers on Release Yoke

The yoke at the left is brand new. The yoke at the right is worn excessively and should be replaced. This wear can be the result of constant riding of the clutch pedal by the driver, and/or failure to maintain free play up in the cab (see Figures 28 and 29 for the resulting damage that can occur to the release bearing).

Consequently, there will be continual contact between the release yoke fingers and the release bearing wear pads. A yoke that is worn excessively may hinder the engagement/control of the clutch. See Figures 1, 5, and 10 for additional photos and descriptions of release yoke failures.

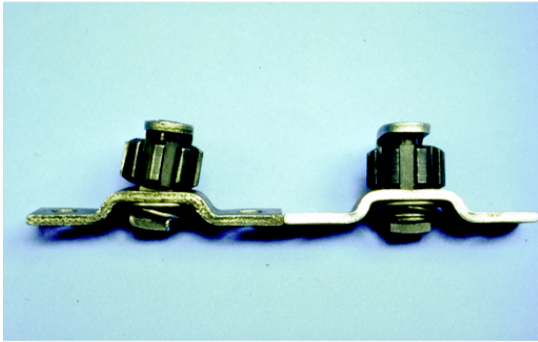
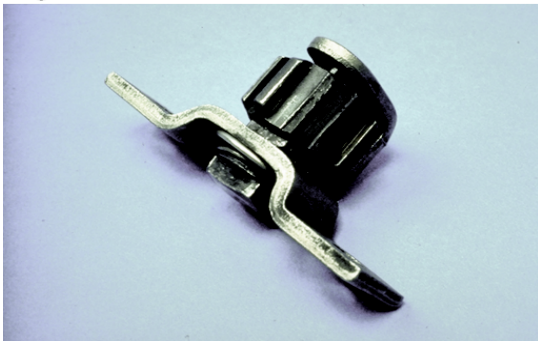
Failure - Bent/Broken Kwik-Adjust® Mechanism

Referring to Figure 71, the kwik-adjuster mechanism at the right is a normal and properly functioning adjuster while the one at the left has been damaged, as evidenced by the bent mounting bracket. The one pictured in Figure 72 also has a bent mounting bracket in addition to some broken gear teeth (see arrow). Some causes of these failures can be:

- Forgetting to depress the kwik adjuster while attempting to rotate the gear.
- Only partially depressing the mechanism while attempting to rotate the gear.
- Attempting to rotate the gear while the clutch pedal is in the up position (clutch is not released).

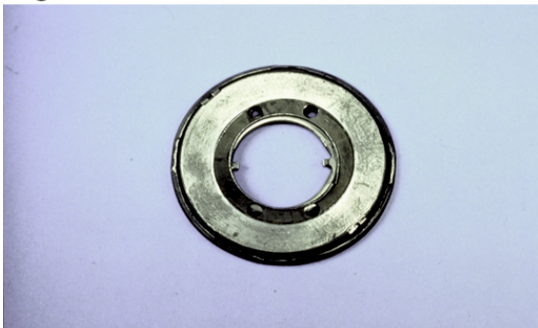
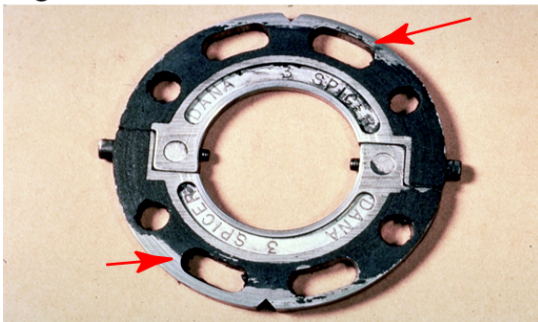
Failure - Worn Clutch Brake

As shown in Figure 73, the facing material on this clutch brake is completely worn away. Figure 74 shows a clutch brake that is partially worn (see arrows). Both types of failures can be attributed to one or more of the following:

- A clutch that is releasing poorly (for corrective action, see the troubleshooting section titled “Poor Release”), thus making it more difficult for the clutch brake to stop the transmission input shaft.
- “Hitting” or engaging the clutch brake when the transmission is in gear and the vehicle is in motion.
- The clutch brake was set too high.
- Installing the new clutch brake in front of a worn/rough transmission bearing retainer cap.
- Clutch brake is simply worn out.

Note: A worn clutch brake should be replaced. Be sure to always check the transmission bearing retainer cap for any wear and replace if necessary (see Figure 3).

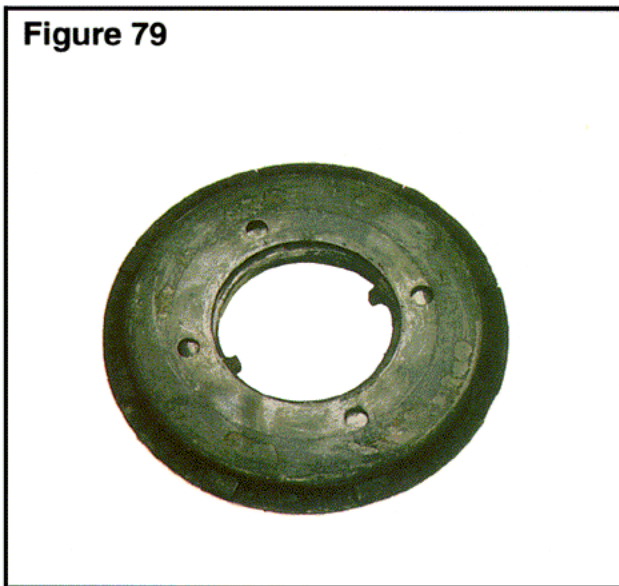
Figure 79

Burnt

Driver Notices: The transmission is hard to shift into first or reverse gears. The clutch may drag.

Observations: Clutch brake is heavily burnt.

Causes: The driver uses the clutch brake when the vehicle is moving. A worn or damaged pilot bearing may cause the clutch to drag.

Correction: Replace the clutch brake. Inspect the transmission input bearing retainer and replace if required. Inspect the pilot bearing and the flywheel and replace if necessary. Make sure the driver uses the clutch brake correctly. This condition is not covered under warranty.

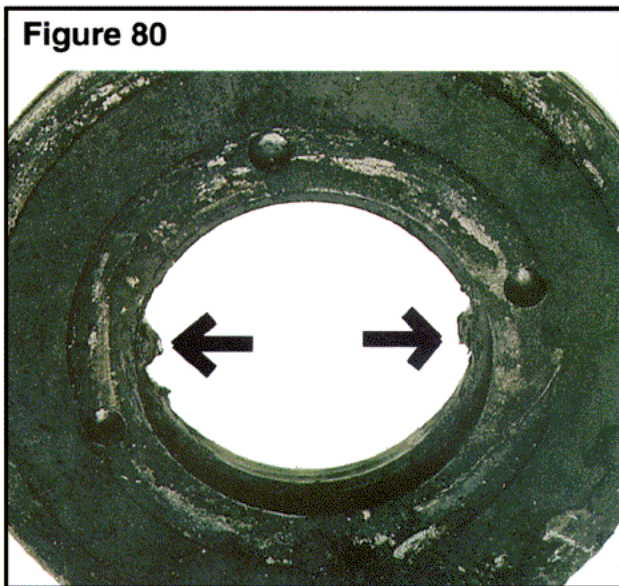
Figure 80

Broken Tabs

Driver Notices: The transmission is hard to shift into first and reverse gears. Also a noise may be heard when the clutch is operated.

Observations: Clutch brake tabs are broken.

Causes: The driver uses the clutch brake when the vehicle is moving.

Correction: Replace the clutch brake. Inspect the transmission input bearing retainer and replace if required. Make sure the driver uses the clutch brake correctly. This condition is not covered under warranty.

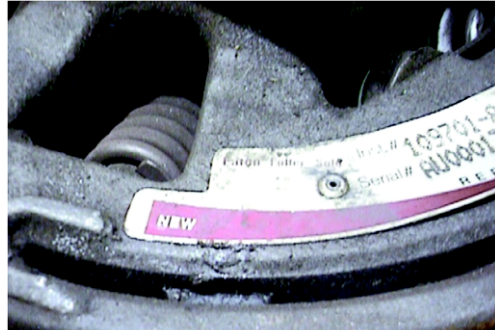
Fig 75

Failure - Solo Cam Tab Broken Off

In Figure 75, the tab was broken when someone was attempting to change the adjustment of the clutch. The clutch cannot break the tab. Many times the tab is broken to change the bearing to clutch brake distance when it is in the proper position. Do not attempt to change the clutch adjustment before measuring the release bearing to clutch brake distance.

Note: Consult the troubleshooting guides for help. If the release bearing is set to the correct dimension, do not attempt to use the cam tab to change the adjustment to the wrong dimension and break off the tab. Troubleshooting guides: CLTS-1296 (Medium-Duty) and CLTS-1295 (Heavy-Duty).

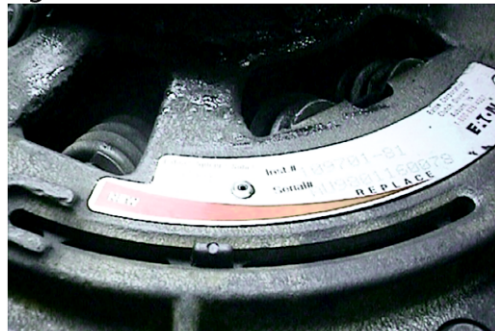
Fig 76

Failure - Solo Over Adjust Problem

Measure the distance between the release bearing and clutch brake. Correct distance should be between .490" and .560" with the pedal up (Figure 76). If the bearing is close to the clutch brake and the clutch has not been removed and re-installed on the flywheel, then an overadjust might have occurred. Consult troubleshooting guides for help. Follow the fault tree for proper diagnosis and correction.

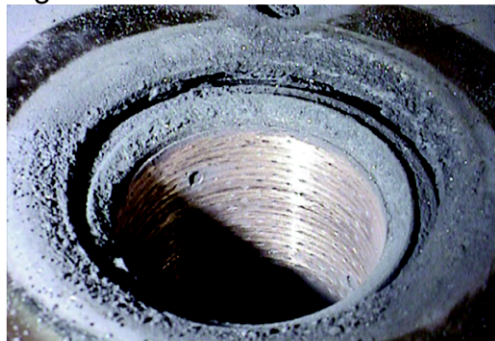
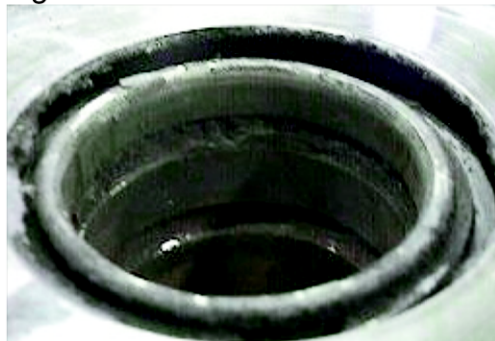
Failure - Bushing Wear and Bushing Failure

As shown in Figures 77 and 78, incorrect lube or not enough lube can cause a failure. External contamination will also cause wear to the bushing. The transmission input shaft may be rough and require replacement. Use approved/compatible lube. (High quality N.L.G.I #2 or #3 lithium soap grease with E.P. additives 325 degree operating temperature). Apply ample lube and let it flow out of the opening from the bearing housing. Apply additional lube onto the transmission shaft to ensure the bushing will have proper lube. Apply lube to the tips of the release yoke.

- Misalignment of input shaft can cause a side load on bushing which will pull it out.
- Worn cross shaft bushings will allow the cross shaft to pull back unevenly resulting in a side load condition on the bushing causing it to come out.

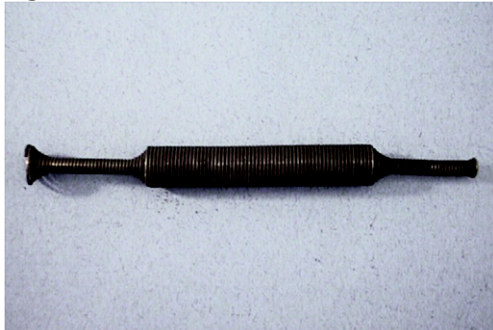
Fig 79

Failure - Solo Cam Tab Spring Broken - Solo Stops Adjusting

- There is an immediate loss of free pedal in the cab.
- The release bearing is touching yoke and too far from transmission.

Consult troubleshooting guides for help. There will be no tension pulling the cam/wear indicator toward "replace." Troubleshooting guides: CLTS-1296 (Medium-Duty) and CLTS-1295 (Heavy-Duty).

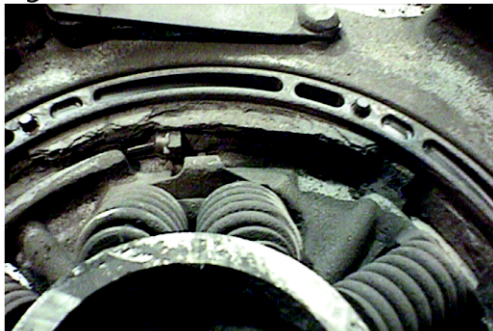
Fig 80

Failure - Solo Adjustment Rings Contaminated - Solo Stops Adjusting

If there is excessive amounts of contamination allowed into the clutch housing, the Solo may stop adjusting and there will be a loss of free pedal in the cab (see Figure 80). Check to see if the inspection cover has been removed. In severe dust applications, it may be necessary to seal all openings in the clutch housing.

Eaton has created a tool that may help free up the clutch to allow it to continue adjusting. #CLPISOLOTOOL can be obtained by calling 800-826-HELP (4357).

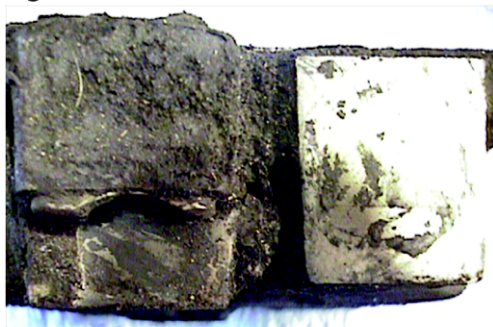
Fig 81

Failure - Worn Wear Pad on Release Bearing caused by Running the Truck without Free Pedal

When the clutch is properly maintained, there should always be free pedal in the cab. This will prevent fork contact with the bearing wear pads and reduce the wear to the pads and the release fork (Figure 81). Follow adjustment instructions for correct clutch and linkage adjustment. Adjust the clutch before free pedal is lost. Apply grease to the yoke fingers to reduce friction when the clutch pedal is stroked.

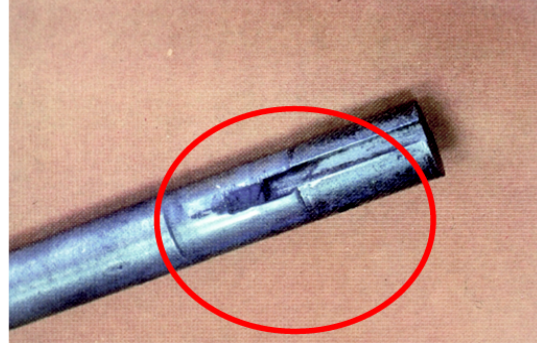
Fig 82

Failure - Cross Shaft Wear

Figure 82 is an example of a worn cross shaft (release shaft). A worn cross shaft (see circle) will occur after high mileage and will be accelerated by a lack of lubrication. Some problems associated with worn cross shafts (and/or worn linkage systems) are:

- Sporadic changes in the amount of free play in the cab
- A binding condition in the linkage system
- Erratic engagement of the clutch
- Side loading of the release bearing housing

As a result, a typical complaint might be that it is impossible to maintain proper clutch adjustment. To prevent future clutch problems, always inspect the linkage system for excessive wear and/or binding conditions before installing the new clutch. Be sure to replace any worn components that might hinder clutch operation. Also, remember to lubricate the linkage pivot points.

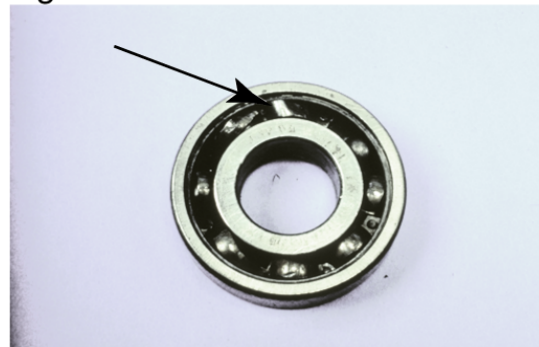
Fig 83

Failure - Seized/Dry Pilot Bearing

- The bearing is dry; it is difficult to turn (rough) or completely seized. Any condition which causes a dry bearing will have been accompanied by a noise complaint while it was in the vehicle.
- A damaged ball bearing cage (see arrow in Figure 83).
- A step is worn into the inner race. The step is caused when the input shaft spins within the inner race, a direct result of the seized pilot bearing.
- The seal is missing and/or damaged because of excessive heat generated by the dry bearing.

A typical complaint associated with a failed pilot bearing (other than noise) is poor release. Poor release can be the result of one or more of the following conditions:

- The outer race of the bearing fits too tightly in the flywheel.
- The inner race of the bearing fits too tightly on the input shaft.

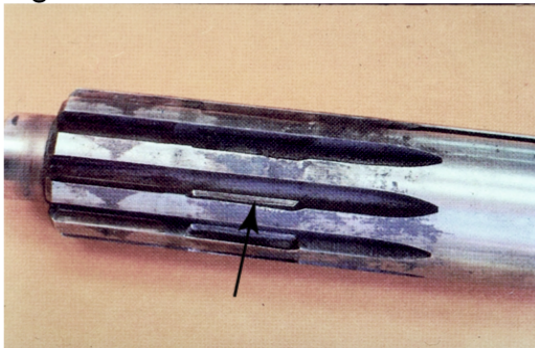
Fig 84

Failure - Input Shaft (Drive Gear) Spline Wear

Drive gear spline wear will cause clutch release problems since the driven discs cannot slide freely on the splines. This is especially true if new driven discs are installed on a worn input shaft (Figure 84). Excessive spline wear can be attributed to torsional vibrations. This type of wear can be eliminated or lessened by the use of dampened driven discs. Spline wear will also occur on the mating driven disc hubs (see Figures 61-62). Misalignment can also be a factor in abnormal spline wear. It is important to always inspect the input shaft for wear before installing a new clutch. If worn, it is recommended that a new input shaft be installed to eliminate possible clutch problems later on.

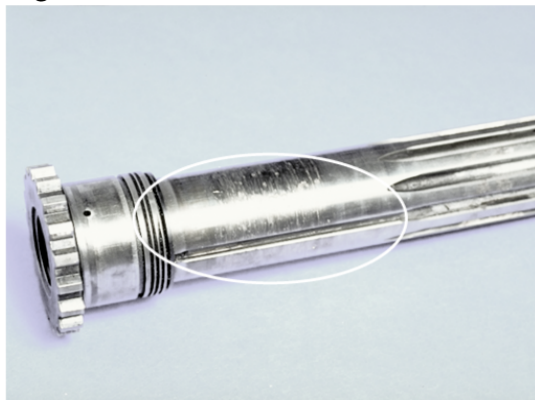
Fig 85

Failure - Galled Input Shaft

This failure resulted when the clutch’s release sleeve was being “side loaded” onto the input shaft (Figure 85). A worn linkage system and/or excessive wear on the release bearing “wear pads” and “release yoke fingers” can cause this side loading condition.

A galled or rough input shaft (in the non-splined area) will damage the bushing(s) of not only the original clutch, but also that of the newly installed clutch. As a result, make sure you replace the input shaft and any worn linkage components to prevent the failure from being repeated.

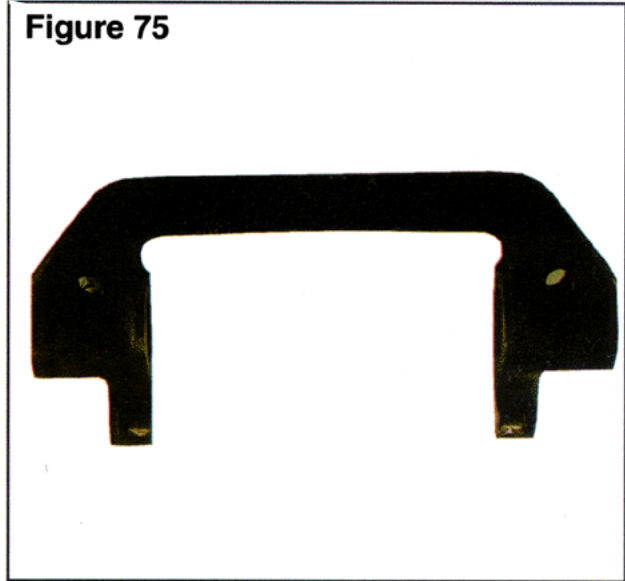
Figure 75

Wear Is Not Even on Tips

Driver Notices: The clutch pedal is hard to push.

Observations: Wear is very different on each tip. The ends of the tip are polished. The cross shaft and the cross shaft bushings are worn or damaged.

Causes: The capscrews that fasten the release fork to the cross shaft were too tight or not tightened evenly. The cross shaft may be damaged. The bushings were not lubricated.

Correction: Replace the release fork. Inspect the cross shaft and the bushings and replace if required. Make sure the bushings are lubricated at the correct intervals. This condition is not covered under warranty.

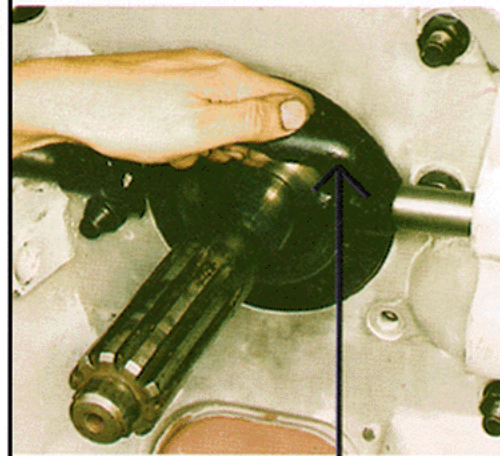
Figure 77

Seized

Driver Notices: The clutch pedal is hard to push and does not return.

Observations: The cross shaft and the bushings are worn or damaged.

Causes: The cross shaft bushings were not lubricated at the specified intervals or with the correct grease.

Correction: Replace the cross shaft and the bushings. Lubricate the bushings at the specified intervals with the correct grease. This condition is not covered under warranty.

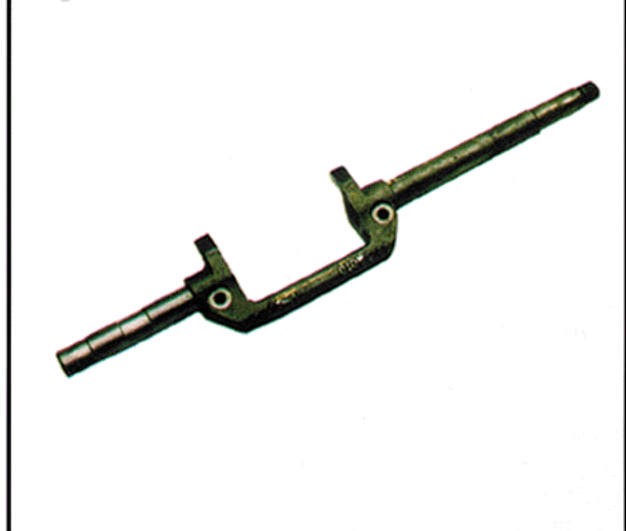
Figure 78

Wear Is Not Even

Driver Notices: The clutch pedal is hard to push down. The clutch may drag or not disengage.

Observations: Wear is different on either side of the shaft.

Causes: The cross shaft bushings were not lubricated at the specified intervals or with the correct grease.

Correction: Replace the cross shaft and the bushings. Lubricate the bushings at the specified intervals with the correct grease. This condition is not covered under warranty.
